DEFENDANTS' MOTION FOR SUMMARY JUDGMENT—EXHIBIT 1  
WILLIAM CARDEN EXPERT REPORT (JAN. 24, 2018)

## Materials Engineering Report

Reference: Clarence Edward Whitaker, etc. v.  
Hyundai Motor Company, et al.

Subject Vehicle: 2007 Hyundai Santa Fe,  
VIN 5NMSH13E57H041555

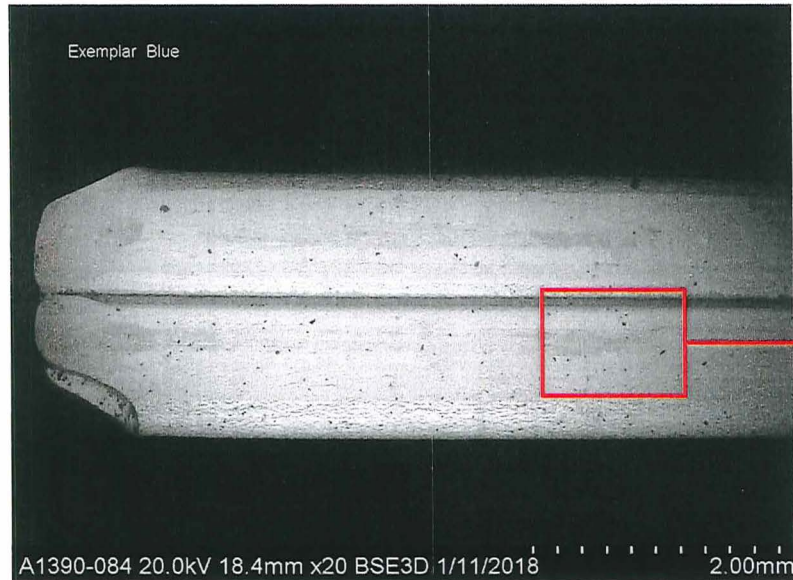
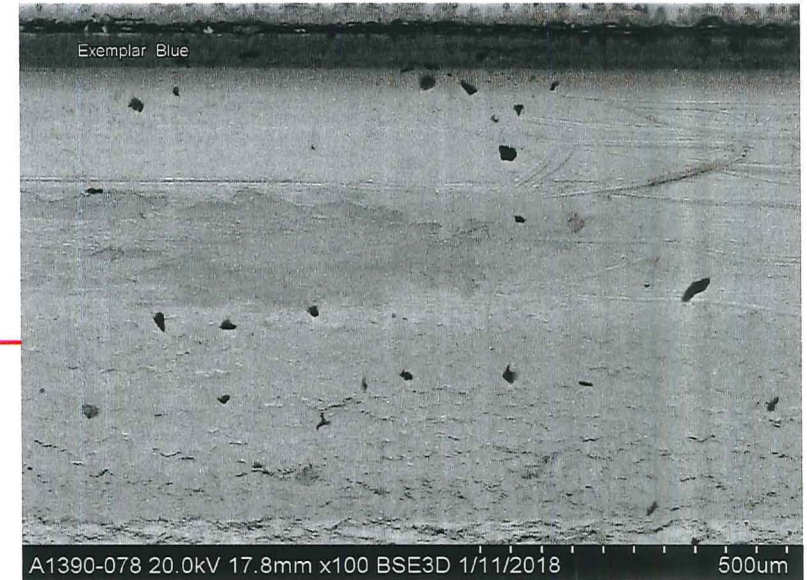
Clarence Edward Whitaker, etc. v. Hyundai Motor Company, et al.  
Subject and Exemplar Ignition Lock Solenoid Connector Blades – Other Side
